Manhole Inspection Summary

Manhole # S37KK_028MH

Insp Date: **3/19/07 12:02 PM**

Location Address: **410 LAFAYETTE AVE**

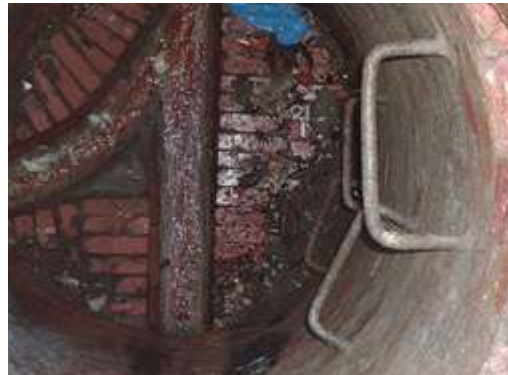
Top View

Corroded steps. Evidence of surcharge - Bench debris.

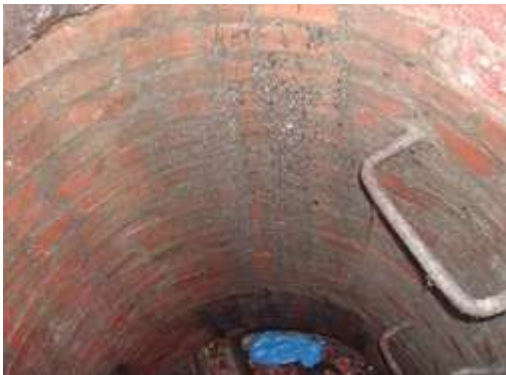
Defect

Frame leaks. Adjustment deterioration and infiltration. Barrel infiltration.

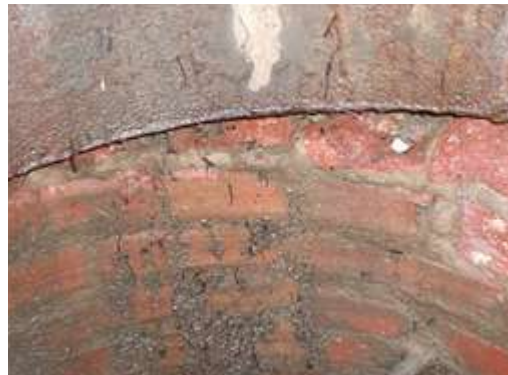
Defect

Frame leaks. Adjustment deterioration and infiltration.

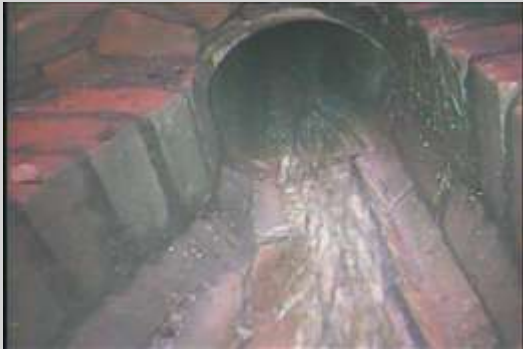
8 in. Circular Gravity Sewer Pipe Out @ 12 O'Clock

Infiltration: **Evidence** Pipe Seal Cond: **Cracked**

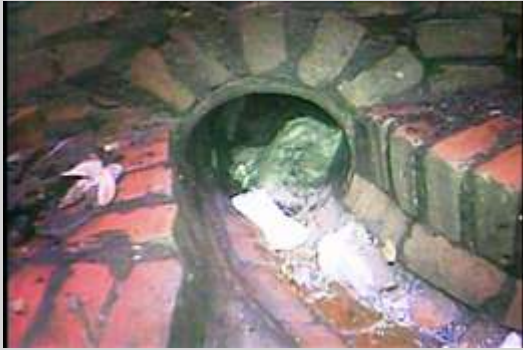
8 in. Circular Gravity Sewer

Deposits: ☐ None ☒ **Mud** ☐ Sludge ☒ **Debris** ☐ Grease

Silt Depth: **3** (in.)

Deposits Extent: **Medium**
